CAMPAIGN 5599 - Service Campaign

Model: Fiat Freemont 2.0 JTD

COMPONENT:	Clutch hydraulic circuit vibration damper			
PROBLEM:	Non-compliance			
VERSION:	Freemont 2.0 JTDM			
CONCERNED VEHICLES:	All vehicles with chassis number listed in SIGI. (Chassis ranging between BT506980 and CT166990) Vehicles assigned to you: consult your PC for the chassis numbers involved in the campaign.			
TECHNICAL CAUSE:	Production process			
RELEASE NO.:	0			
MATERIAL:	Description:	Part No.:	Q.ty:	
	Cap	K68166291AA	01	
SPECIAL TOOLS:	-			
EPLUS ORDER UPLOADING METHOD:	-			
REMUNERATION:	Cost:	Campaign:	Operation:	Time:
MANPOWER AND MATERIAL:	A01	5599	A	0.20
			B	0.55
MISCELLANEOUS (MAIL, ETC.):	A10	5599	-	-
SOLUTION IN PRODUCTION:	Correct lay-out guaranteed			
NETWORK INTERVENTION IDENTIFICATION:	A spot of white paint on the upper right side of the engine cover

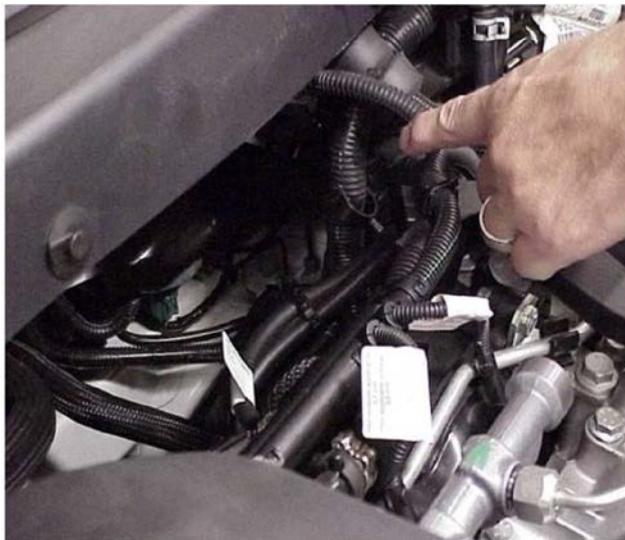
Fig. 1 Engine compartment

- Remove the engine cover.
 - Check if the clutch hydraulic circuit vibration damper is fitted in the engine compartment.
 - If the damper is not present in the engine compartment, the vehicle is compliant.
 - If the damper is present in the engine compartment the car is non-compliant and you need to proceed as below described:
1. stick your arm in the engine compartment with an oil absorbing towel and place it under the damper (Fig. 1)

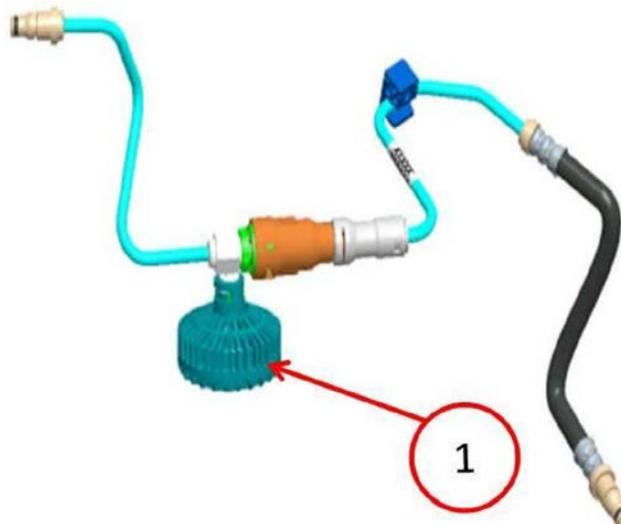
Fig. 2 Hydraulic line with damper

1 - Damper

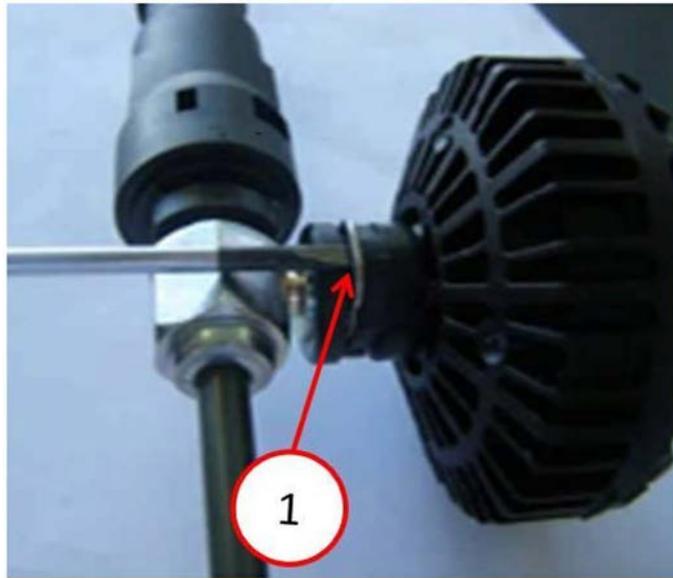
Fig. 4 Clutch damper

1 - Damper retaining clip

2. Stick your arm in with a small screwdriver.
3. Locate the damper and rotate it so that you can see the damper retaining clip (Fig. 4).

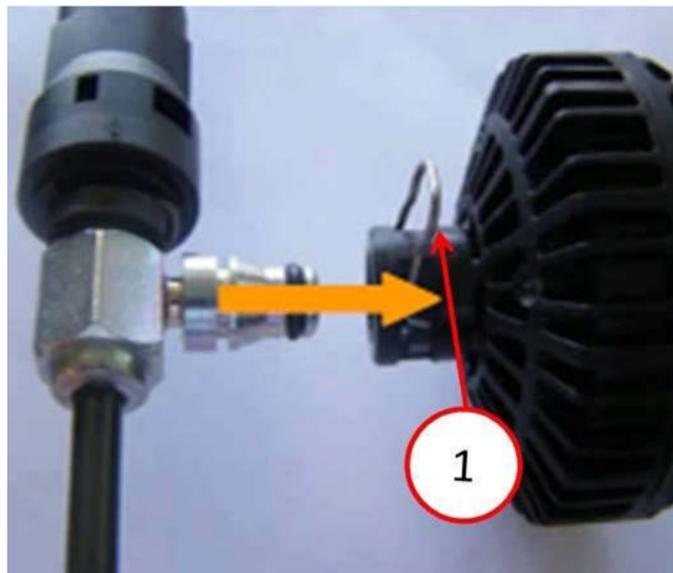
Fig. 5 Clutch damper

1 - Clip pulled out

4. Pull the retaining clip out to the stop, remove the damper and discard it (Fig. 4) and (Fig. 5).

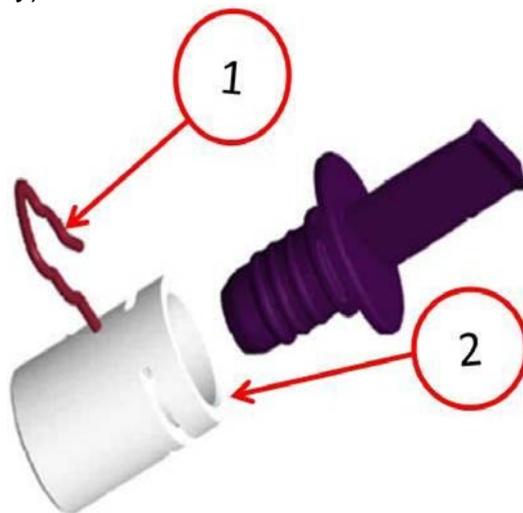
Fig. 6 Clutch cap

- 1 - Clip
 - 2 - Cap
-

5. Install the retaining clip onto the new cap, p/n K68166291AA (Fig. 6) (see Part&Service availability).

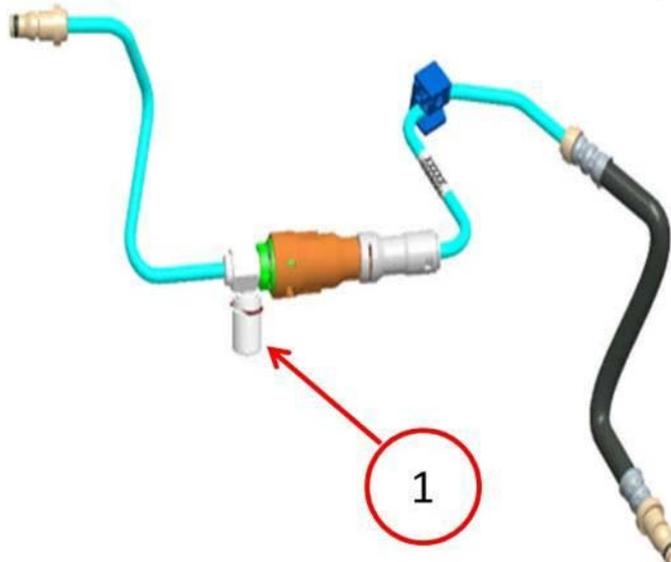
Fig. 7 Hydraulic line with cap

- 1 - Cap
-

6. Install the cap onto the hydraulic line in place of the damper (Fig. 7).

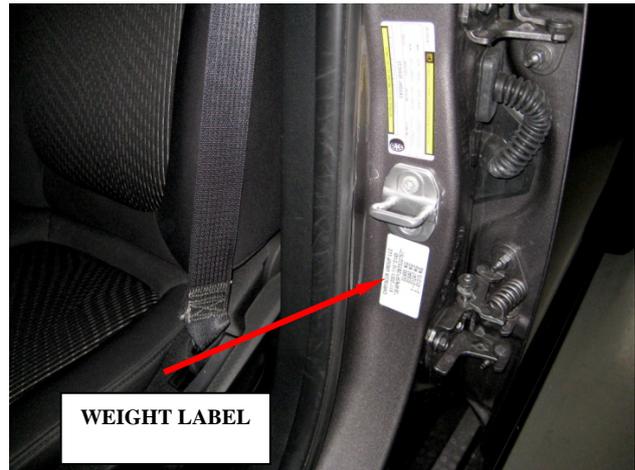
Fig. 1 – Driver's side B-pillar

COMPONENT:	Weight and particulate labels			
PROBLEM:	Non-compliance			
VERSION:	Freemont 2.0 JTDM			
CONCERNED VEHICLES:	All vehicles with chassis number listed in SIGI. (Chassis ranging between BT506922 and BT564308) Vehicles assigned to you: consult your PC for the chassis numbers involved in the campaign.			
TECHNICAL CAUSE:	Production process			
RELEASE NO.:	0			
MATERIAL:	Description:	Part No.:	Q.ty:	
<hr/>				
<hr/>				
SPECIAL TOOLS:	-			
EPLUS ORDER UPLOADING METHOD:				
REMUNERATION:	Cost:	Campaign:	Operation:	Time:
MANPOWER AND MATERIAL:	A01	5599	C	0.20
MISCELLANEOUS (MAIL, ETC.):	A10	5599	-	-
SOLUTION IN PRODUCTION:	Compliant labels are guaranteed			
NETWORK INTERVENTION IDENTIFICATION:	A spot of white paint on edge of the labels

1. Open the driver's door and locate the weight label on the driver's side B-pillar, as shown in Fig. 1.
2. Select the correct weight label as determined by seating capacity (see label description in Parts&Service Availability).
3. Clean the existing weight label with alcohol, glass cleaner or equivalent and a soft cloth to remove any dirt, oil residue or grease.
